# Report on the Loss of the Mars Polar Lander and Deep Space 2 Missions

JPL Special Review Board

22 March 2000

JPL D-18709

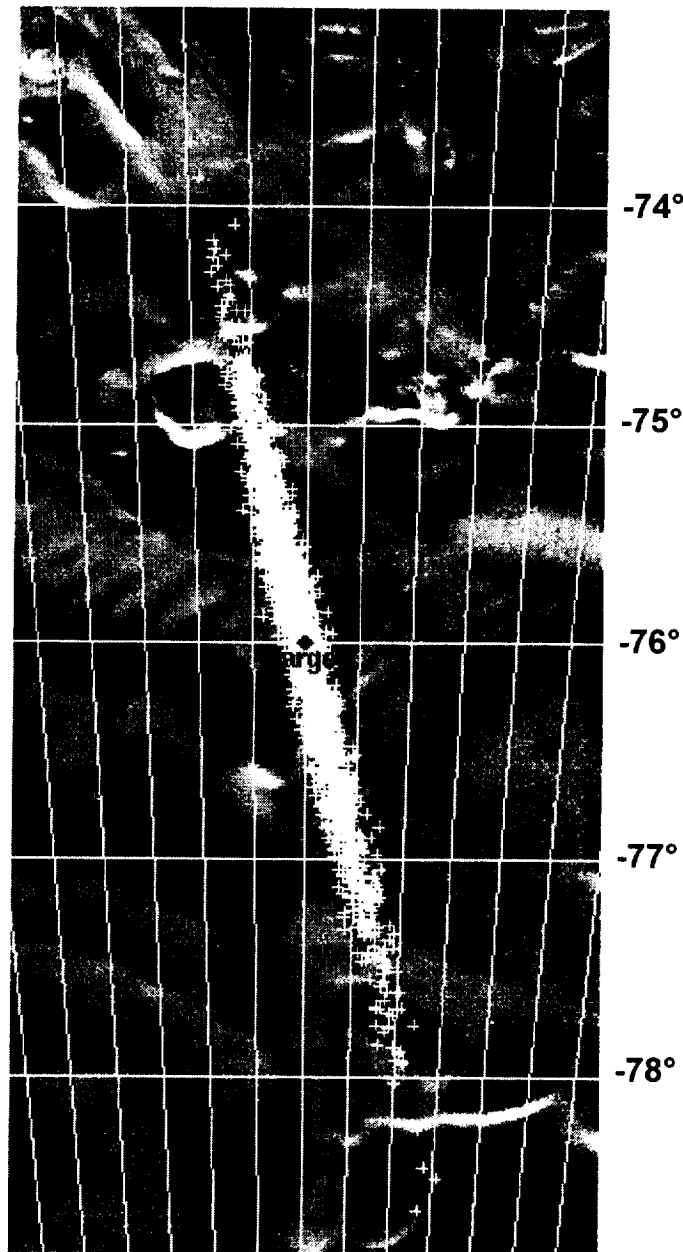
**Figure 7-1. Site Selection Ellipse —  
Based on LMA Scatter for 75° S, Rotated for 76° S Landing Site**

Additionally, in order to achieve the desired landing ellipse on the surface of Mars, the analysis assumed that the spacecraft center of mass could be controlled to within 2.8 millimeters of the centerline of the entry body. The resulting surface ellipse had dimensions of 85 kilometers semi-major axis (along-track) by 5.4 kilometers semi-minor axis (cross-track), both 2 sigma. Figure 7-1 shows the landing ellipse estimate at the time of the site selection several months before EDL, based on earlier 3DOF/4DOF LMA Monte Carlo simulations, adjusted in orientation to the new landing latitude of  $-76^\circ$  S. (*Note: The landing latitude was  $-75^\circ$  at launch.*)

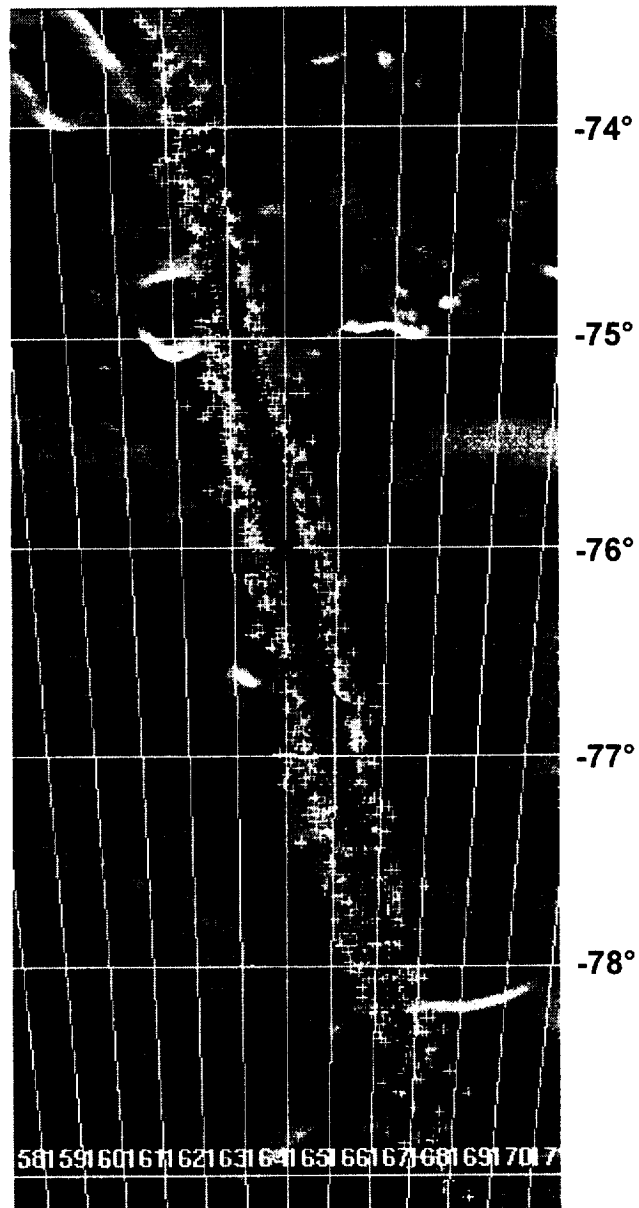
**Figure 7-3. Required Maneuver-Execution Errors, LaRC 6DOF 3/3/00 (Yellow [Light]) and TCM-4 Planning Ellipse, LaRC 3DOF 11/23/99 (Green [Dark])**

Analyses performed after EDL revealed that the effects of maneuver-execution errors were larger than expected. The TCM-4 planning ellipse was based on a maneuver magnitude of 0.35 meter per second, the best estimate available at that time. The final TCM-4 maneuver magnitude was 0.6 meter per second. This maneuver magnitude resulted in considerably larger execution errors than had been previously assumed. For very short burns, execution errors are small because little time is available for pointing errors to develop. For longer burns, errors are also small because the control system will steer back to the desired attitude. The executed burn magnitude fell in between these extremes and, therefore, was subject to a larger set of expected errors. This increased the size of the 3-sigma B-plane error to as high as 20.5 kilometers  $\times$  13.8 kilometers, using worst-case requirement estimates of maneuver-execution errors. (Typical or "expected" maneuver-execution errors led to substantially smaller B-plane errors (18.3 kilometers  $\times$  6.2 kilometers). This widening effect is illustrated in Figure 7-3, which shows both the narrow TCM-4 planning ellipse, based on the assumed maneuver magnitudes and associated error statistics, and the wider ellipse, based on the actual maneuver magnitude and associated error statistics. This graphic represents the difference between the delivery accuracy that the project assumed was achievable at the time of TCM-4 versus what is now believed to be the best estimate, after the fact. Also shown is the center of the final navigation solution based on tracking data after TCM-5 through the loss of signal.

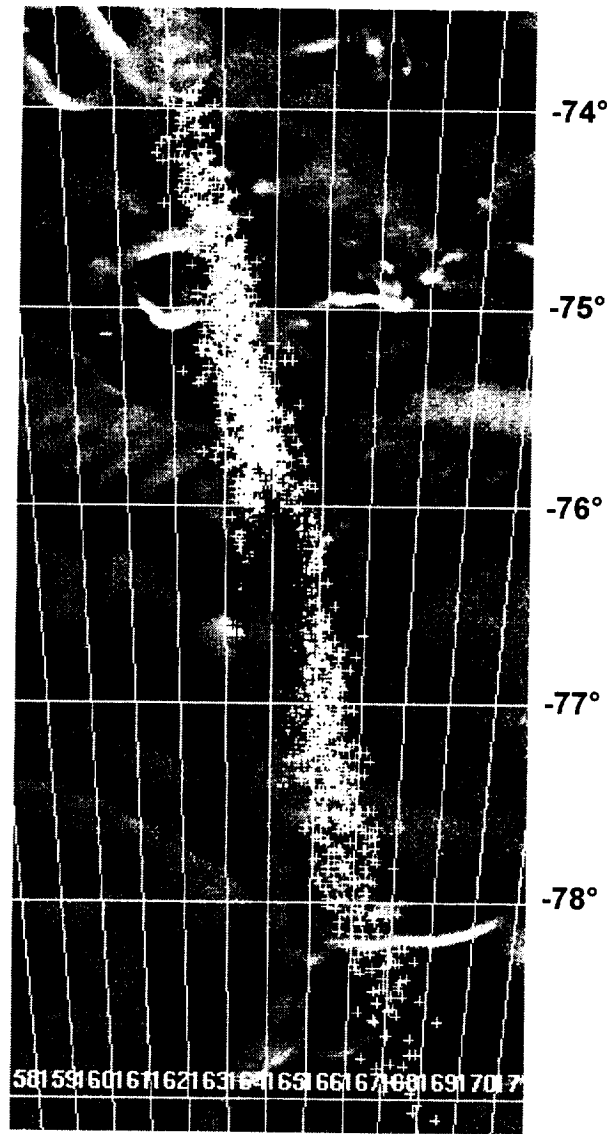
**Figure 7-4. Required Maneuver-Execution Errors, LARC 6DOF 3/3/00 (Yellow [Light]) and Final Estimated Ellipse, LARC 6DOF 3/3/00 (Green [Dark])**

On the basis of the final pre-entry tracking, the desired in-plane entry conditions appear to have been met. The entry flight-path angle was reconstructed at  $-13.10$  degrees against the target zone of  $-13.25 \pm 0.94$  degrees (revised from the original  $-13.25 \pm 0.54$  degrees). The cross-track error in the B-plane was within 7.2 kilometers of the planned target, which corresponds to a motion of approximately 8 kilometers at the surface. This distance is marginally consistent (within approximately 2 sigma) with the eventual understanding of the uncertainty surrounding the spacecraft small-forces environment and TCM-4 execution errors, which are discussed above. In Figure 7-4, the yellow (light) data once again reflect the best estimate of the delivery accuracy after TCM-4; these data are based on analysis after the fact. Also in Figure 7-4, the green (dark) data represents the best estimate of where the lander actually did go, eliminating effectively all navigation errors by using the final tracking data arc through loss of signal, but continuing to represent scatter around that final solution due to atmospheric and aerodynamic uncertainties.

Some concern has been expressed regarding how close the ultimate landing site was to a questionable terrain feature immediately to the west of the reconstructed landing site. Features equally hazardous appear further north on the western edge of the planned landing ellipse and on the eastern edge of the landing ellipse. These risks were known and accepted when the landing site was selected and did not represent risks that were higher than any alternative landing site during the early fall of 1999 at the time when a burn could have been executed to move the landing site. During the days prior to EDL, the cross-range drift (subsequently attributed to TCM-4 execution errors) was observed; however, as previously discussed, the project maneuver strategy did not allow for cross-track corrections at TCM-5.

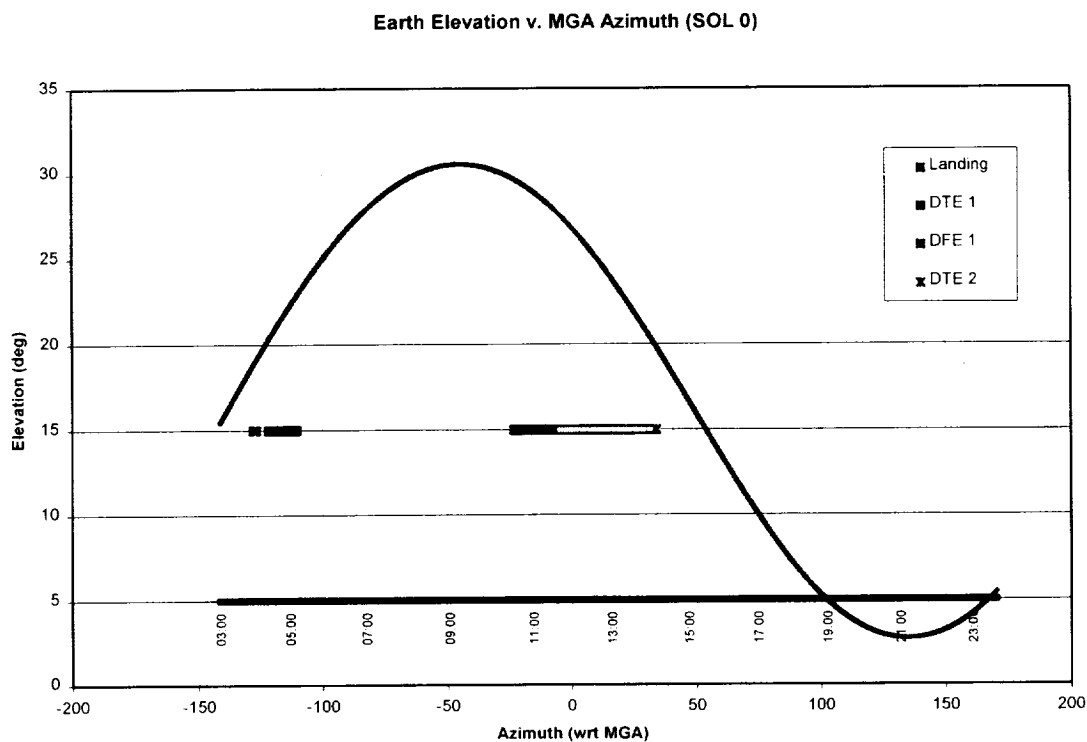
**Figure 7-5. Earth Geometry for the Nominal Landing Orientation and Site on Sol 0**

On sol 0, Earth was above 10 degrees elevation for azimuth angles of  $-150$  degrees to  $+75$  degrees (in the nominal landing attitude). Earth elevation peaked at  $\sim 32$  degrees above the horizon. The azimuth and elevation "soft stop" ranges are:  $-138$  degrees  $< AZ < 51.5$  degrees,  $2$  degrees  $< EL < 57$  degrees. The sol 0 Earth geometry is shown in Figure 7-5.

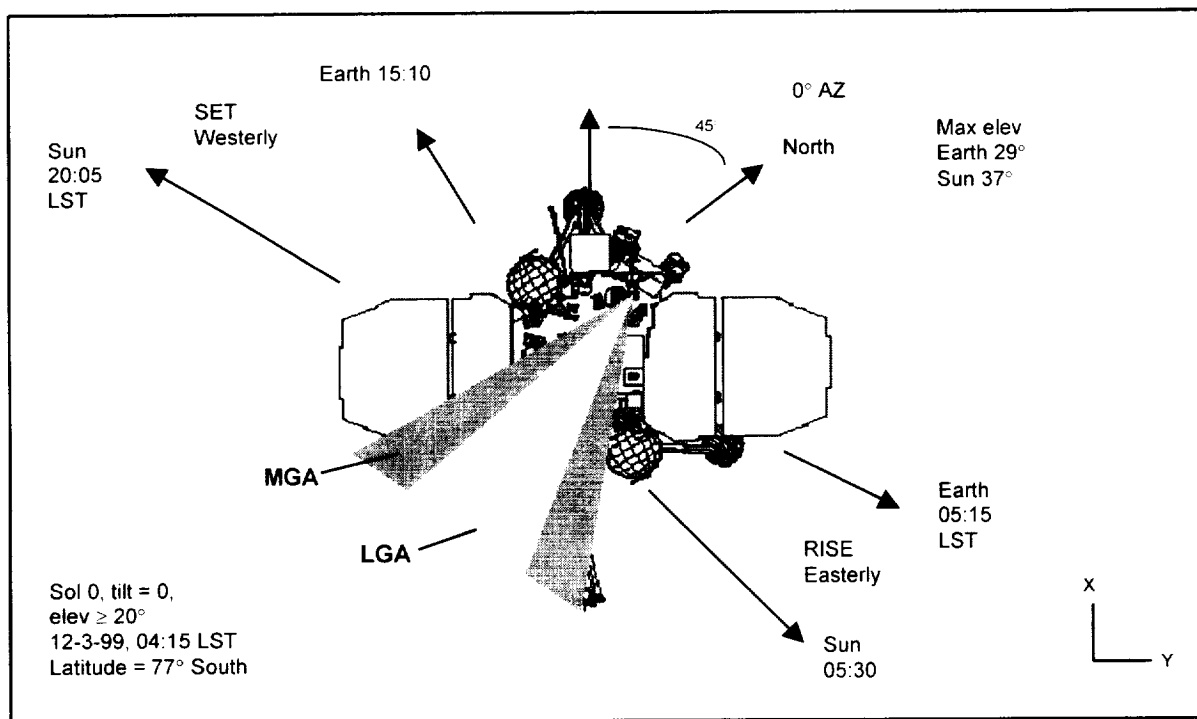
**Figure 7-6. Command-Blind Zones in Azimuth for MGA (125 bps) and LGA (7.8125 bps)**

For downlink, the "blind" zone is similar if no "touchdown power-on reset (POR)" scenario occurs that would kick off the autonomous Find the Earth (FTE) sequence (see Figure 7-6). Otherwise, the Telecom Subsystem would have been configured for carrier-only downlink for the duration of the sequence, which increases the field of view around the MGA to approximately 30 degrees. In carrier-only mode, a downlink signal would almost certainly have been observed from Earth during the FTE sequence, if the landing azimuth error had been less than 36 degrees (6 degrees FTE minimum "pad" plus 30 degrees field of view).
